EXHAUST EJECTOR, JACKET, ASSY, LHS REPAIR SCHEME

MODEL: BELL 212, 412, 412CF & 412EP

Revision: NI Part No.: AAL-061-207-001

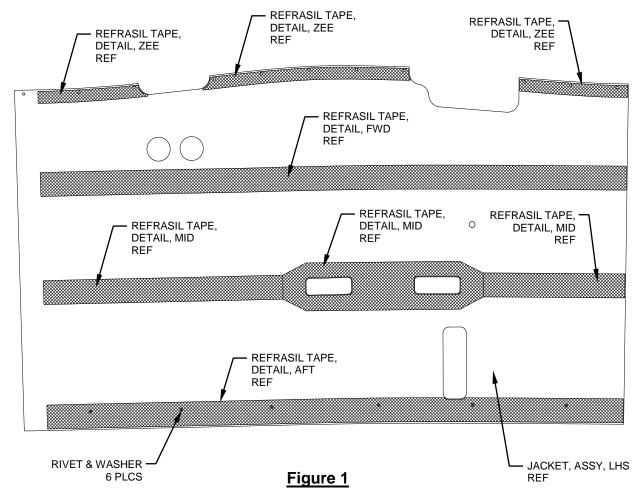
VIEW LKG AT INNER SURFACE OF JACKET, ASSY, LHS FLAT PATTERN SHOWN FOR CLARITY

1. Place masking tape on the inner surface of the Jacket, Assy, LHS to mark the locations of the existing Refrasil Tape, Details as required. Remove the rivets and washers retaining the existing Refrasil Tape, Detail, AFT as shown. Remove and disregard all existing Refrasil Tape, Details. Reference Figure 1.

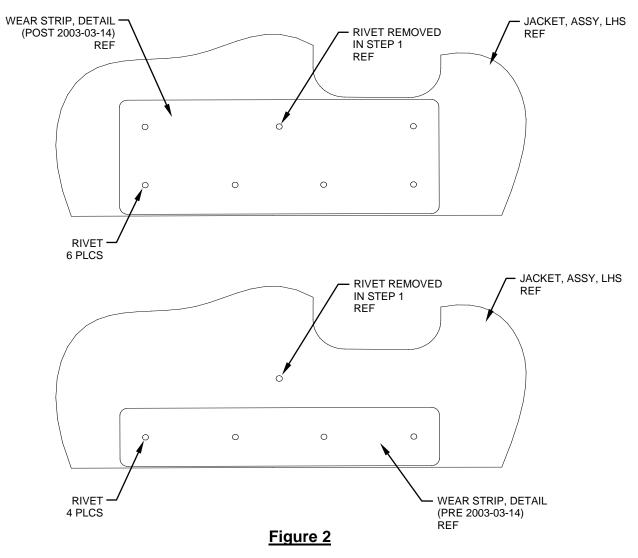
VIEW LKG AT OUTER SURFACE OF JACKET, ASSY, LHS FLAT PATTERN SHOWN FOR CLARITY (POST & PRE 2003-03-14 CONFIGURATIONS SHOWN)

2. Remove the rivets retaining the existing Wear Strip, Detail as shown. Remove and disregard the existing Wear Strip, Detail. Reference Figure 2.

NOTE: Removal of existing Wear Strip, Detail is <u>NOT</u> mandatory if its present condition is acceptable.

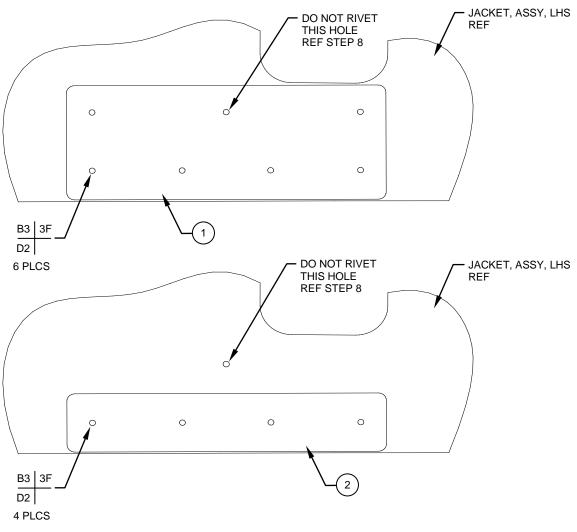
Figure 3

VIEW LKG AT OUTER SURFACE OF JACKET, ASSY, LHS FLAT PATTERN SHOWN FOR CLARITY

- 3. If applicable, clean the faying surface of the new Wear Strip, Detail (Item 1 or 2 as applicable) and Jacket, Assy, LHS with Xylene.
- 4. If applicable, install the new Wear Strip, Detail (Item 1 or 2 as applicable) and rivet in position as shown. Reference Figure 3.
